ENERGY

CORROSION PROTECTION COATINGS FOR CERAMIC FIBER COMPOSITE MATERIALS

Dr. Hagen Klemm, Willy Kunz, Dipl.-Ing. (FH) Bernd Gronde, Dipl.-Ing. Katrin Schönfeld

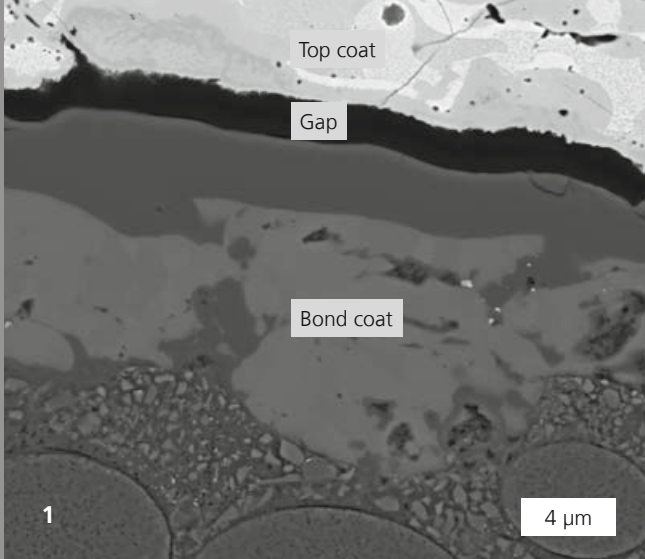
- 1 *Typical damage mechanism of an EBC in a hot gas environment due to gap formation.*
- 2 *Layer composition of Al_2O_3 bond coat with TiCN particles after oxidation (1200 °C, 100 h).*

Environmental barrier coatings (EBC) may be helpful in slowing these processes down significantly. Typical current EBC systems with good functionality consist of a bond coat from silicon, and a corrosion-resistant topcoat, such as BSAS, rare-earth silicates, YAG or ZrO_2 and HfO_2 compounds. Si bond coats are particularly suitable since their thermal coefficient of expansion is comparable to that of the CMC. The Si layer additionally acts as an effective diffusion barrier against O_2 and H_2O penetrating into the ceramic fiber composite material. Nevertheless, the diffusion of O_2 and H_2O into the CMC down into the Si bond coat was found to be a major reason for failure in long-term application. As the result of this diffusion, oxidation processes were observed at the Si layer/topcoat interface. A SiO_2 layer was formed (thermal-grown oxide, TGO), which corroded in hot-gas environments. The associated material loss led to the formation of a gap, which resulted in the flaking of the EBC system with continued use. In order to prevent the formation of the TGO layer and thus improve the lifetime of the EBC sys-
